Roof

Introduction

The existing flat roofs on the Hall of Waters were inspected by Susan Richards Johnson & Associates, Inc. (SRJA) and Structural Engineering Associates, Inc. (SEA) in order to determine if the roofs and related assemblies were performing according to their intended installation, to identify signs of weakness or deterioration and to recommend maintenance and repairs. In general, the roofs were visually inspected and the following conditions were reviewed: the continuity of the roof covering; deterioration of the roof covering; dispersement of rock ballast; visible ponding of water; existing roof drains; existing roof penetrations; installation of metal parapet caps; metal flashings (through-wall and regletted) and sealant installations. Interior spaces were also reviewed in relation to adjacent ceilings and walls for signs of water infiltration and/or distress. Photographs were taken at each roof during the inspection. The roofs were inspected in June 2012, in the midst of a drought, and therefore, no leaks were noticeable at the time of survey.

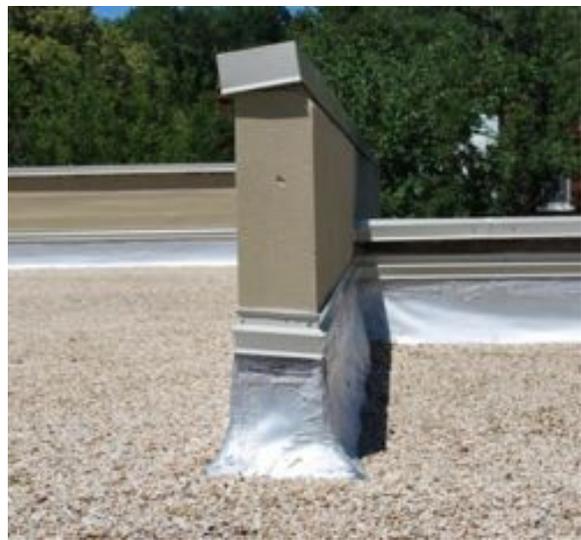
Fig. 107 Lower Roof (R1) Detail, Looking North at Loosened Metal Cap Flashing (SRJA 2012)

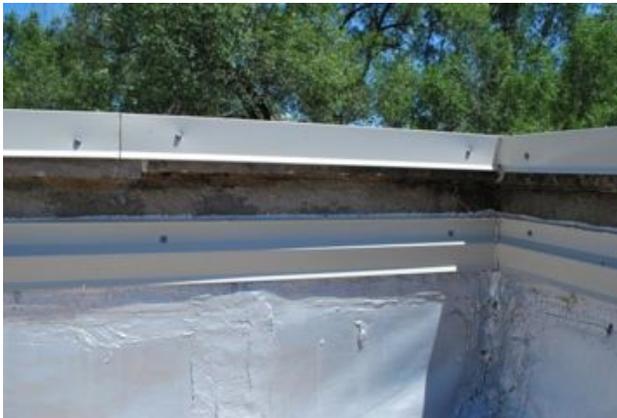
The parapet wall capstones are clad with prefinished aluminum cap flashing with a drip edge on both the exterior and interior faces. It is unknown how the cap flashing is installed to the capstones below, though they may just be face-screwed, as shown in Figure 103. The cap flashing appears to be adequately overlapped at the seams. The seams are sealed with caulking. The caulking is beginning to show signs of deterioration and is in need of removal and replacement.

Fig. 103 Lower Roof (R1) Detail, SE Corner (SRJA 2012)

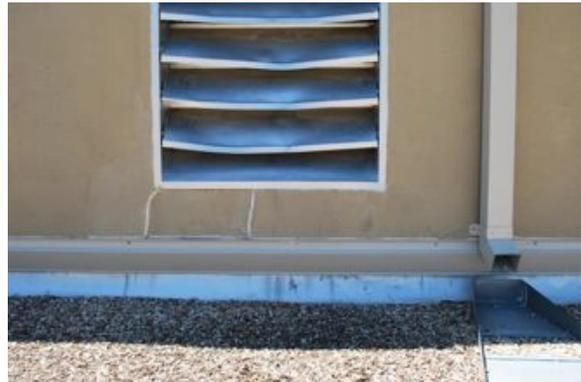
Fig. 106 East Wall Fan Room, Multiple Cracks and Previous Repairs in Wall Areas (SRJA 2012)

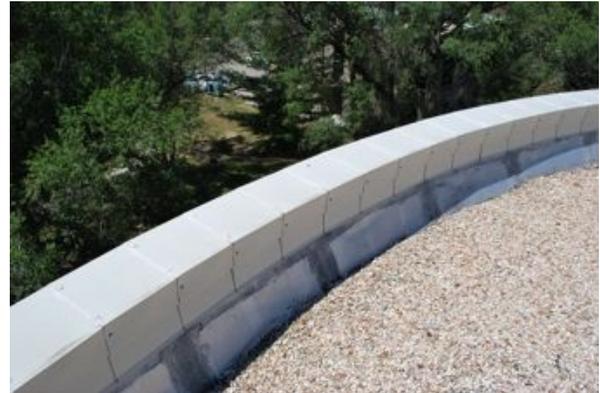
The parapet walls are constructed with masonry backup and are faced on the exterior with cut stone. The parapets are topped with cut stone capstones and are clad with metal cap flashing. The parapet walls are very low surrounding this roof; and therefore, the roofing materials are rolled up the back side of the parapet and are terminated under flashing which is lapped under the prefinished cap flashing. The flashing is fastened with screws into the concrete parapet wall. At the building intersections, the roofing is turned up and terminated with the same flashing. It is unknown if the base flashing (which is not visible) is regletted into the building, as would be the preferred detail. The top side of the termination flashing at the building is filled with sealant. The sealant appears to be in good condition, though yearly inspection and maintenance is recommended. The exposed portions of the rolled roofing material on the back side of the parapet walls appears to be in good overall condition, though previous patches are visible in some areas. The cap flashing over the curved southern section of the parapet is segmented in order to accommodate the radius of the wall. These joints are sealed with caulking along the top surface joints, which currently appears to be in good condition. These joints should be examined on a frequent basis and should be completely removed and reinstalled when they begin to show signs of deterioration. It is unknown what the lap joint coverage is for this cap flashing. A minimum of 4 inches is recommended.

Fig. 111 Hall of Waters Roof (R2) Looking South at Segmented Cap Flashing on Curved Parapet (SRJA 2012)

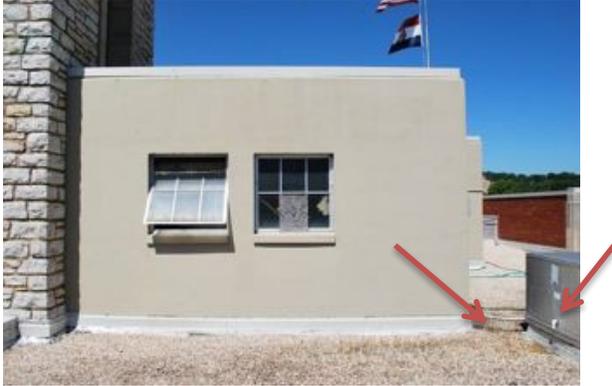
There are three primary roof drains, each with an adjacent overflow drain. The eastern-most drain is located just north of the Elevator Penthouse. The furthest point on the roof from this drain is 37 feet. Between the condensing unit and the Penthouse, there was a large area of standing water on the roof during the inspection. This consistently damp area allows for the growth of small plants. The condensate pipe on the condensing unit is left to drain directly onto the roof. This needs to have a new hose connected to exit directly into the roof drain without traveling across the roof. The plants need to be removed so that they do not clog the drain or damage the roof surface.

Fig. 114 Hall of Waters Chambers Roof (R4) Looking West. The left arrow points to area of standing water and plant growth. The right arrow points to the condensate pipe which is left to drain onto the roof. (SRJA 2012)

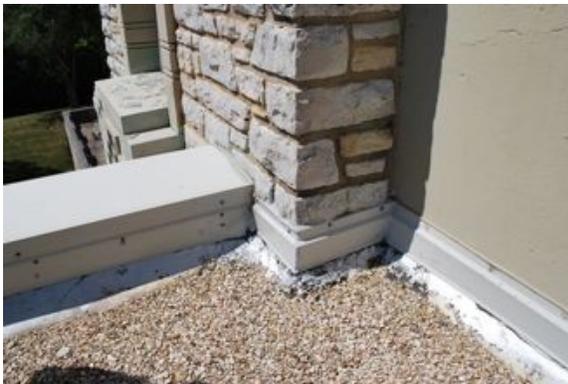
Fig. 112 Hall of Waters Chambers Roof (R4) Looking South. Detail of flashing at penthouse wall. (SRJA 2012)

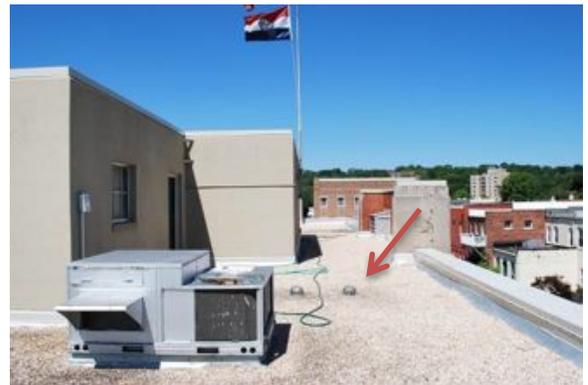
Fig. 115 Hall of Waters Chambers Roof (R4) Looking West. The east roof drains are located behind the condensing unit. The taller north building entrance parapet wall is in the background. (SRJA 2012)

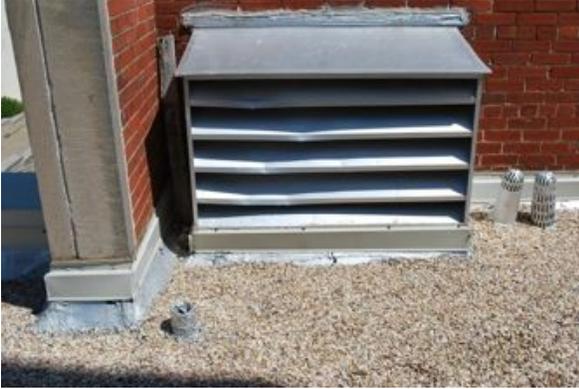
The parapet wall over the north building entrance differs from the other parapet walls. This wall is just over six feet in height and is has exposed brick on the back side. The brick mortar is showing signs of wear and should be repointed 100%. The condition of the stone capstone is unknown, as it is covered with the metal flashing. Prior to repointing, the condition of the capstones should be exposed and observed.

Fig. 119 Hall of Waters Chambers Roof (R4) Looking North. This photograph shows the backside of the north building entrance brick parapet wall. The plumbing vent is in the foreground, with the louvered vent in the center and the central roof drain to the right of the vent. (SRJA 2012)

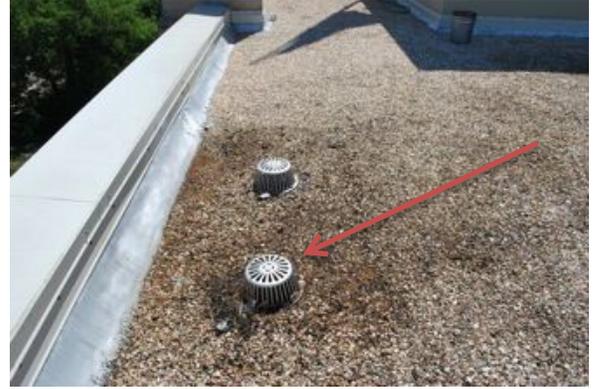
The western-most roof drain (and the adjacent overflow drain) is located toward the north end of the roof over the court room (Figures 118 and 122). Water from the southeast portion of this roof must travel over 44 feet in order to reach this drain. The drain appears to be in working order, though at the time of inspection, there was some standing water adjacent to the drain where there were some small plants growing. This drain should be inspected to determine why there is water ponding at this location that is not entering the drain. The plant growth needs to be removed so it does not clog the drain and so that it does not damage the roof material.

Fig.122 Hall of Waters Chambers Roof (R4) Looking East. This photograph shows the roof drain with standing water and plant growth. The plants are difficult to see in this photo, as they were brown during the time the photographs were taken. (SRJA 2012)

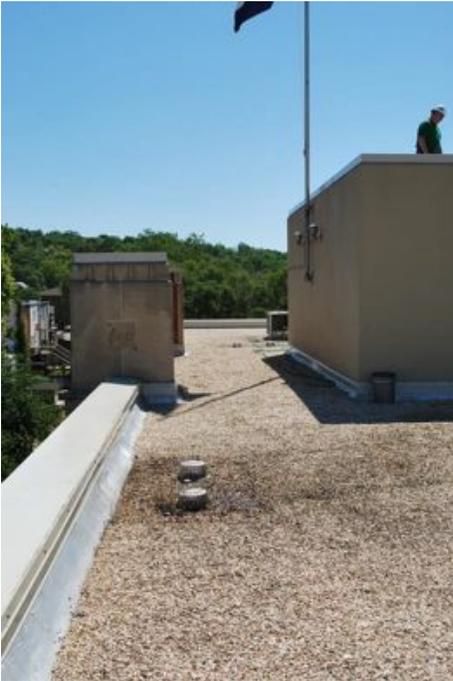
Fig. 118 Hall of Waters Chambers Roof (R4) Looking East at Western-most Roof Drain. (SRJA 2012)

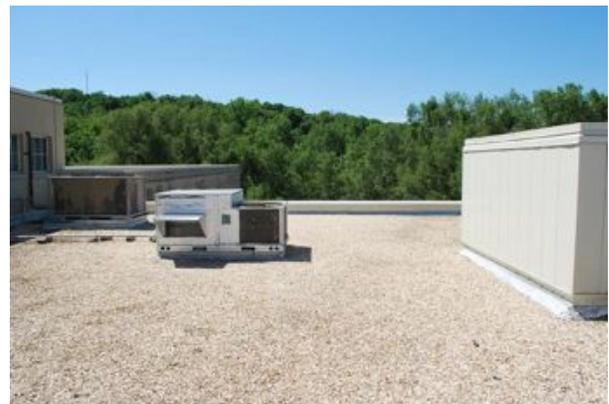
The western portion of Chambers Roof (R4) over the Court has two large roof-mounted condensing units set on roof curbs (Figures 120 and 127). When inspected, this roof section of roof appeared to be in overall good condition. However, the roof area between the condensing units and the penthouse had standing water and evidence of significant plant growth. Both of the condensing units need new condensate drain hoses installed, which should drain directly into the roof drain instead of traveling across the roof to the drain. The existing condensate hose appears to come from an interior unit, through the west penthouse wall (Figure 125). This hose is too short and needs to be taken directly to the western-most roof drain. There is also quite a bit of leaf, roofing debris material and dead plant material, especially in the southeast section of this roof, which needs to be cleaned up in order to allow for proper roof drainage.

Fig. 120 Hall of Waters Chambers Roof (R4) Looking South. (SRJA 2012)

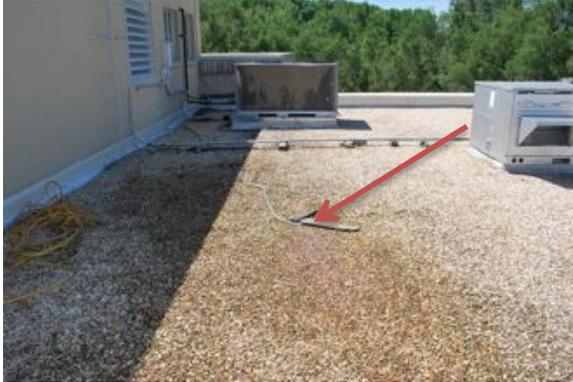
Fig. 125 Hall of Waters Chambers Roof (R4) Looking South. Note the shortened condensate hose with a significant amount of standing water and plant growth. This hose needs to be lengthened and taken directly to the roof drain. The plant growth needs to be removed. (SRJA 2012)

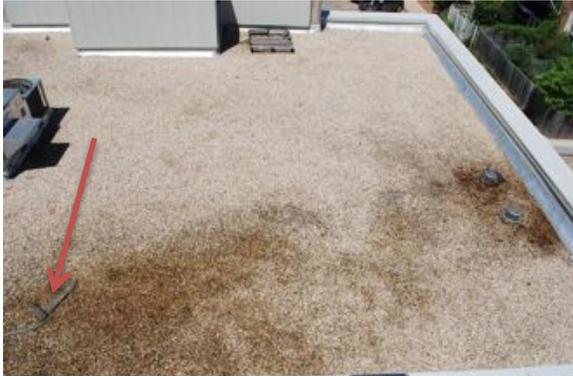
Fig. 124 Hall of Waters Chambers Roof (R4) Looking West. The red arrow points to the standing water at the end of the condensate hose. Boards have been placed on the hose to keep it weight it down and direct the water towards the drain. The western-most roof drain is in the right of the photograph. (SRJA 2012)

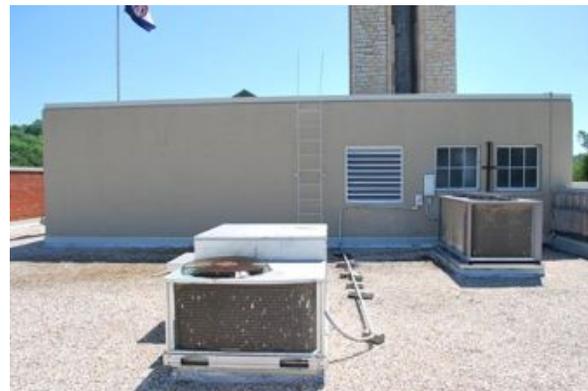
Fig. 127 Hall of Waters Chambers Roof (R4) Looking East. (SRJA 2012)

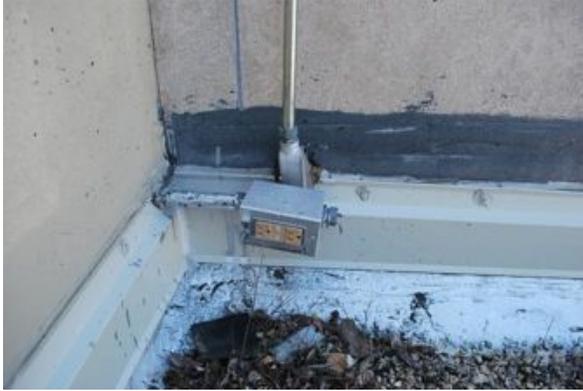
In the very southeast corner of this section of roof, an uncovered GFCI electrical outlet has been drilled through the west Penthouse wall (Figure 129). It should be determined whether this outlet is required and if it is not, it should be removed and the hole through the concrete Penthouse wall should be repaired and the existing flashing patched or replaced. The top of the roof flashing sealant in this location should be completely removed and reinstalled, as it is showing signs of deterioration.

Fig. 129 Hall of Waters Chambers Roof (R4) Looking South. Southeast corner of the west part of the roof. This uncovered GFCI needs to be inspected and removed if unused or reinstalled, if required. (SRJA 2012)

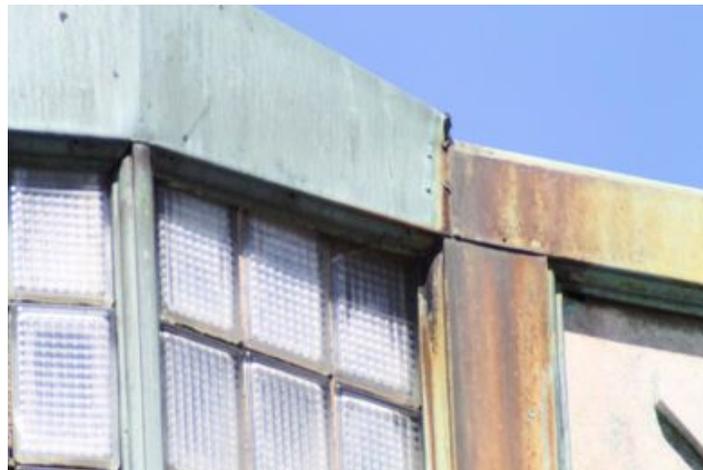
The Tower Roof (R7) is located atop the large stone tower. The roofing material appears to be a combination of copper flashing and standing seam copper roofing. The Design Team was unable to inspect the roof due to the height of the tower. Photographs taken from a distance away from the building show that the copper roof system and the integral boiler stack are deteriorated. It is recommended that the replacement of the roofing system and associated flashings be addressed as part of the overall tower rehabilitation.

Fig. 144 Hall of Waters Tower Flashing Deterioration Detail. (SRJA 2012)

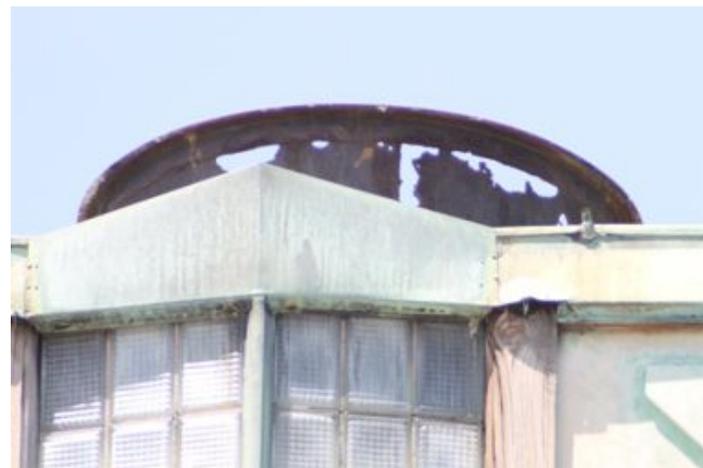
Fig. 145 Hall of Waters Tower Flashing and Boiler Stack Deterioration Detail. (SRJA 2012)

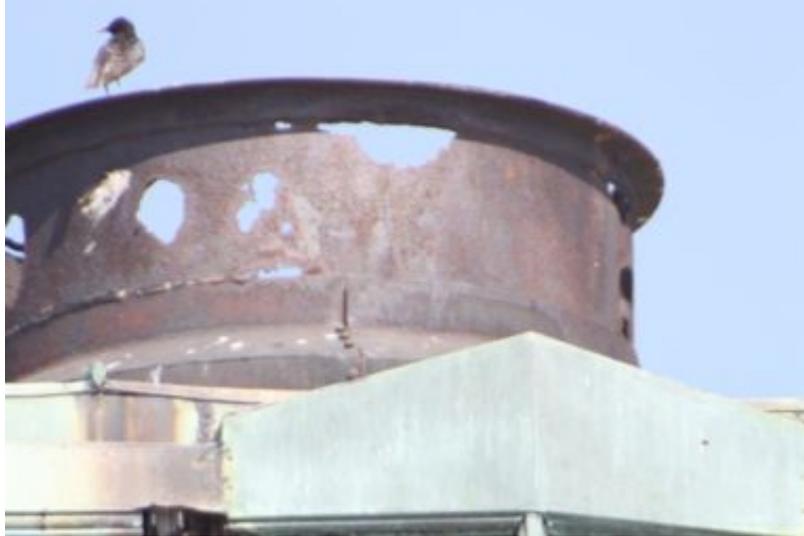
Fig. 146 Hall of Waters Tower Flashing and Boiler Stack Deterioration Detail. (SRJA 2012)
