1. Survey No. CL-AS-010-020		2. Survey name: Mineral Water Resources of Excelsior Springs	
3. County: CL		4. Address (Street No.) 312	Street (name) E. Foley Street
5. City: Excelsior Springs	Vicinity: <input type="checkbox"/>	6. UTM: 15 S/ 394790.14E/4355575.05N	7. Township/Range/Section: T: 52N R: 30W S:1
8. Historic name (if known): Muriated Soda Spring		9. Present/other name (if known): W. W. Lesinger residence	
10. Ownership: <input checked="" type="checkbox"/> Private <input type="checkbox"/> Public		11a. Historic use (if known): HEALTH CARE/resort facility DOMESTIC/Single dwelling	11b. Current use: VACANT/not in use

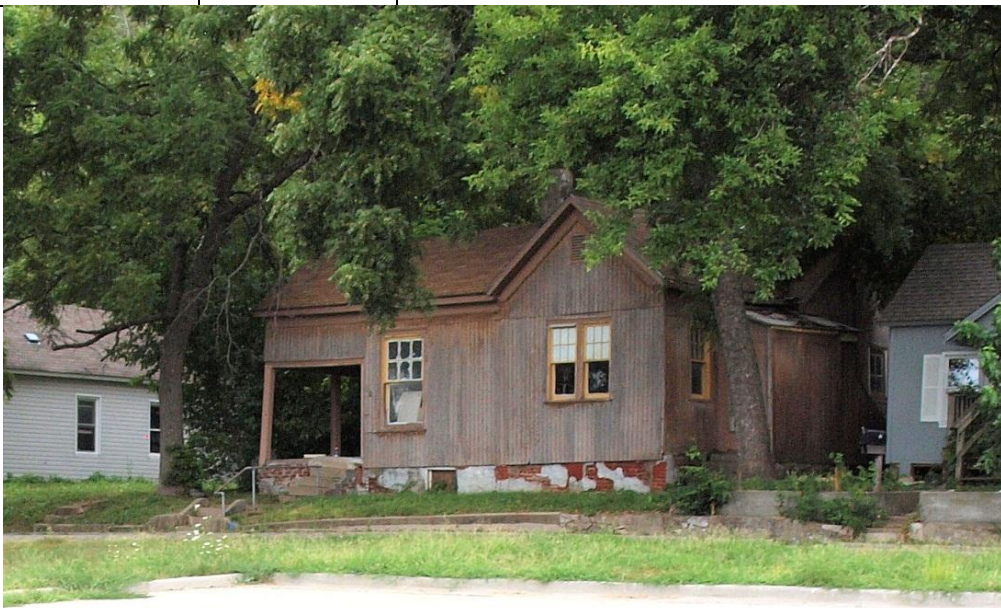
Photographer: Deon Wolfenbarger	Date: 7/29/2011	Description: Looking northwest at front (south) and east elevations
------------------------------------	--------------------	--

(the house was demolished during the course of this survey project – description is pre-demolition). This one-story cross-gable roof house has a porch on the west side which extends the west gable roof; the entry is on the west side of the house beneath the recessed porch. The siding is vertical plywood board panels. The brick foundation was covered with stucco which is failing, showing the brick beneath. A square bay window is on the east elevation. Windows are 6/1, and were broken at the time of the survey.
