MISSOURI DEPARTMENT OF NATURAL RESOURCES STATE HISTORIC PRESERVATION OFFICE, P.O. Box 176, Jefferson City, MO 65102 ARCHITECTURAL/HISTORIC INVENTORY FORM

1. Survey No. CL-AS-010-024		Survey name: Mineral Water Resources of Excelsior Springs					
3. County: RY		4. Address (Street No.) 12859		Street (name) Orrick Road			
,		6. UTM: 15 S/ 3	6. UTM: 15 S/ 395539.34E/ 4353342.88N		7. Township/Range/Section: T: 52N R: 29W S:18

8. Historic name (if known): Blue Rock Spring, Blue Rock Lithia Well, Old Smith Spring 9. Present/other name (if known): Easley Residence							
10. Ownership: ☐ Private ☐ Public		11a. Historic use (if known): HEALTH CARE/resort fac see current use)			11b. Current use: DOMESTIC/single dwelling; AGRICULTURE/ Agricultural field; storage		
HISTORICAL INFORMA	ATION

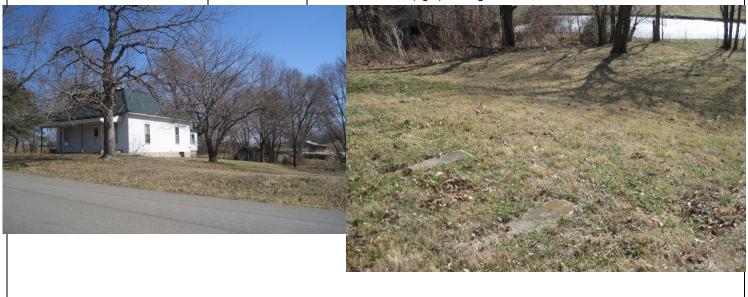
PHOTOGRAPH

(left) Looking northeast at front (west) & south elevations, & south yard – location of well; (right) looking south east across stone stair well remnants

41. (cont.) Further description of important architectural features. Expand box as necessary, or add continuation pages. The few visible at-grade remnants of the spring site are located on the south side of the historic farmhouse. There are two rectangular concrete panels sunk in the ground, and are likely the tops of the supporting walls for the steps that led down into the sunken spring, although further investigation is warranted. Each section measures between 2.5'-3.5' in length, and 10"-12" in width

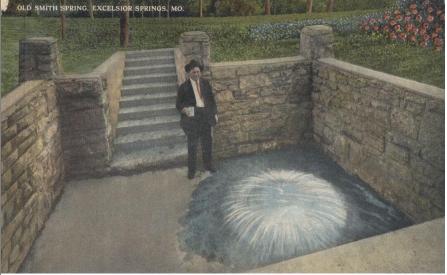
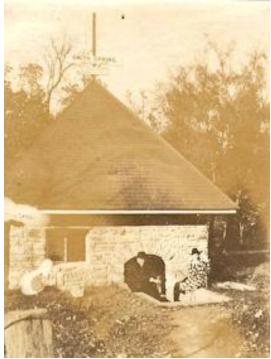
Historic postcard

Photograph courtesy Dennis Hartman.
