1. Survey No. CL-AS-010-034		2. Survey name: Mineral Water Resources of Excelsior Springs	
3. County: CL		4. Address (Street No.) 528	Street (name) Caldwell Avenue
5. City: Excelsior Springs	Vicinity: <input type="checkbox"/>	6. UTM: 15 S/ 394443.72E/ 4355808.80N	7. Township/Range/Section: T: 52N R: 30W S:1
8. Historic name (if known): Sulphur Salt-Soda Spring		9. Present/other name (if known):	
10. Ownership: <input checked="" type="checkbox"/> Private <input type="checkbox"/> Public		11a. Historic use (if known): HEALTH CARE/resort facility	11b. Current use: DOMESTIC: single dwelling

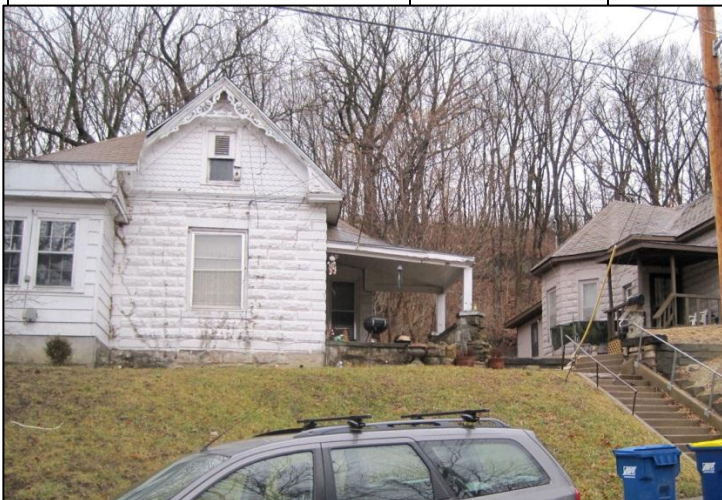
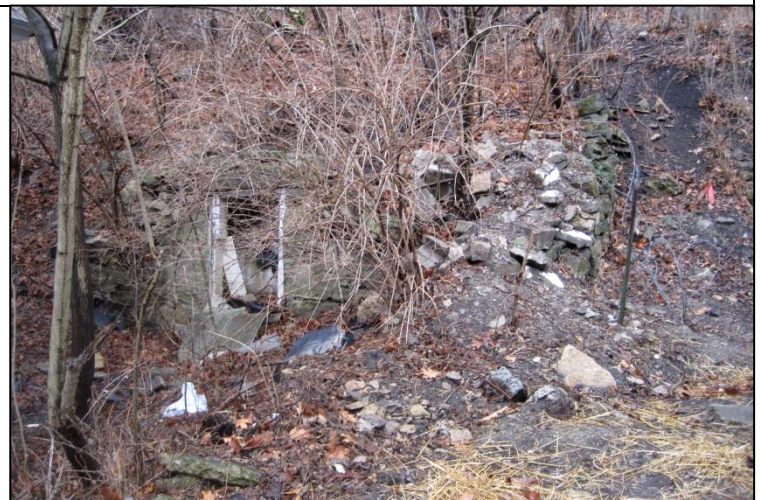
**PHOTOGRAPH**

Description:  
(left) Looking west at east & north elevations & former pavilion site next to road; (right) looking northwest at east elevation, former pavilion site

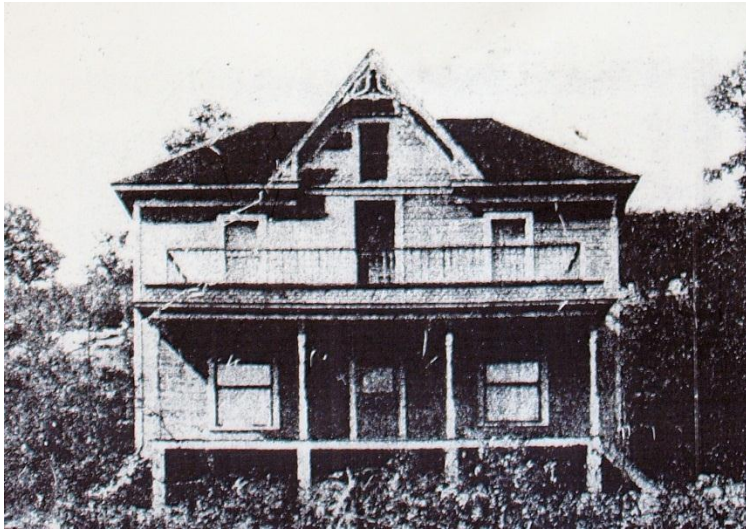
**Historic photograph of building associated with Sulphur-Salt Soda Spring**

The Sulphur Salt-Soda Springs was discovered in July 1906 at a depth of 126 feet. It was located in the Sunnyside addition, which was platted in 1904 (possibly indicating development of the area occurred immediately following platting). It was located just north of the Relief Spring on Caldwell Avenue; the historic photograph below shows the large two-story frame house that was purportedly associated with the spring [this house is no longer extant on Caldwell]. The waters belonged to the *Soda Bicarbonate* group, and purportedly could be drunk in generous quantities and had a general tonic effect on the entire system. Miss M. Bierman was the owner of the spring, and for the first few months after its discovery, it was offered free. However, the well does not show up on any historic maps or in the available city directories. In 1908, M. Bierman is not listed at any address on Caldwell, and both 526 and 528 Caldwell (north of Relief) were vacant. Oral interviews with residents revealed a well, recently filled in, at the back of 528 Caldwell; and one resident had heard that a larger boarding house was formerly at 528 Caldwell. Examination of the property indicated remnants of possible foundation for a larger building that may have predate the extant house. There are also extant historic foundations on the vacant lot to the south: the location of this well is thus an estimate of either 526 Caldwell (vacant) or 528 Caldwell (where the recently filled in well was merely a personal well serving the residents only).
