Roof

Introduction

The existing flat roofs on the Hall of Waters were inspected by Susan Richards Johnson & Associates, Inc. (SRJA) and Structural Engineering Associates, Inc. (SEA) in order to determine if the roofs and related assemblies were performing according to their intended installation, to identify signs of weakness or deterioration and to recommend maintenance and repairs. In general, the roofs were visually inspected and the following conditions were reviewed: the continuity of the roof covering; deterioration of the roof covering; dispersement of rock ballast; visible ponding of water; existing roof drains; existing roof penetrations; installation of metal parapet caps; metal flashings (through-wall and regletted) and sealant installations. Interior spaces were also reviewed in relation to adjacent ceilings and walls for signs of water infiltration and/or distress. Photographs were taken at each roof during the inspection. The roofs were inspected in June 2012, in the midst of a drought, and therefore, no leaks were noticeable at the time of survey.

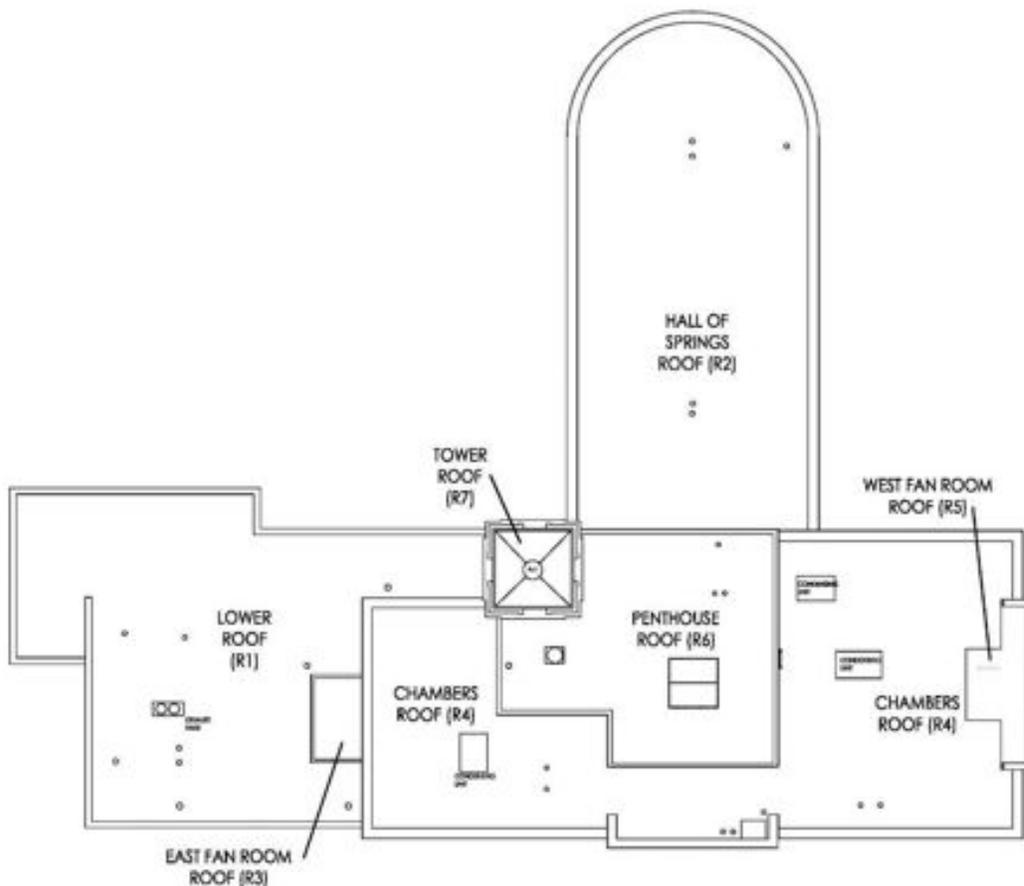
Fig. 102 Roof Plan. (SRJA 2013)

There are many levels of roofs (Figure 102). All roofs were accessible for inspection except the Tower Roof (R7). The roofs, in general, appear to be in overall good condition.

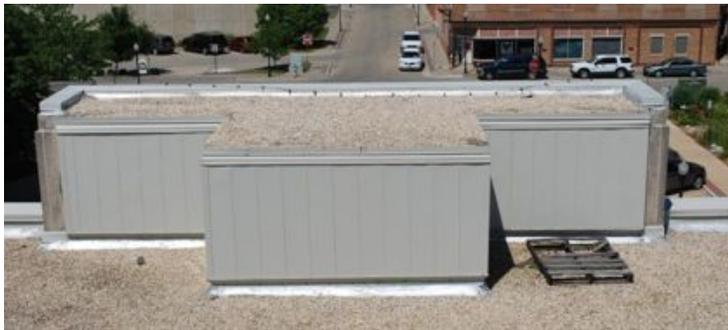
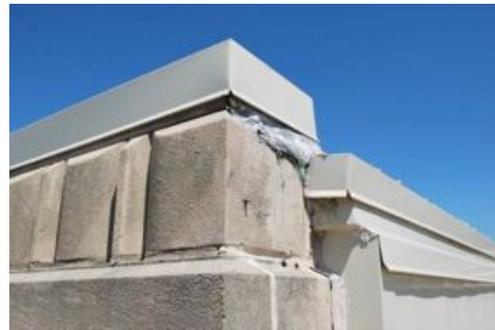
Fig. 130 Left: West Fan Room Roof (R5). (SRJA 2012)
Fig. 131 Right: West Fan Room Roof (R5) Detail. (SRJA 2012)

The West Fan Room Roof (R5) is approximately 164 square feet and covers only the small west fan room. A very low u-shaped parapet cap runs along the north, west and south sides of the roof. The roof is relatively flat and is covered with rock ballast, which is held in place with a metal gravel stop along the eastern perimeter. There are no visible roof drains in this area. The water overflows the gravel stop and drains directly to the roof below. There are no signs of visible water infiltration within the West Fan Room. This roof should be watched during a large rain event to determine if there is any ponding on the roof during or after a storm, due to lack of established drainage. The north and south parapet wall / capstone / roof intersections are not detailed with metal flashings, but appear to depend upon roofing material and sealants, per Figure ?. Careful monitoring at these intersections is important to ensure leaks do not develop in these locations.

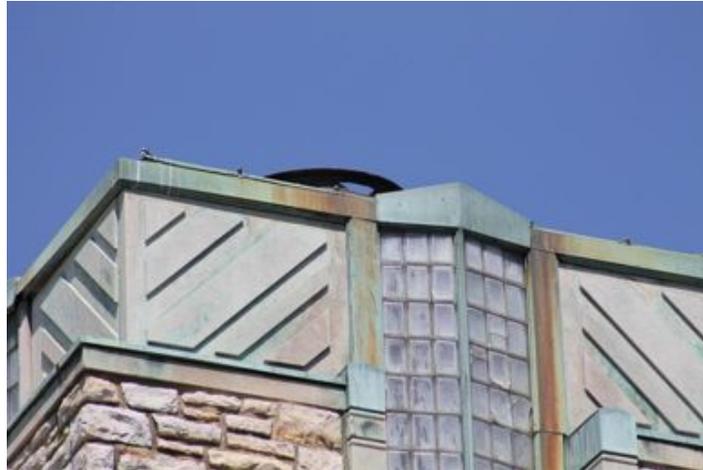
Fig. 143 Hall of Waters Tower. (SRJA 2012)

The Tower Roof (R7) is located atop the large stone tower. The roofing material appears to be a combination of copper flashing and standing seam copper roofing. The Design Team was unable to inspect the roof due to the height of the tower. Photographs taken from a distance away from the building show that the copper roof system and the integral boiler stack are deteriorated. It is recommended that the replacement of the roofing system and associated flashings be addressed as part of the overall tower rehabilitation.
